Project: Bag House Protection

The Problem

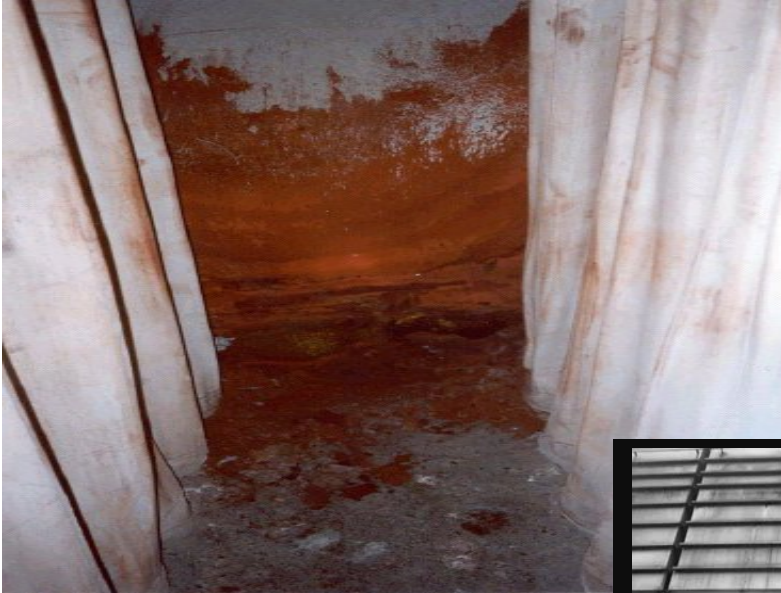
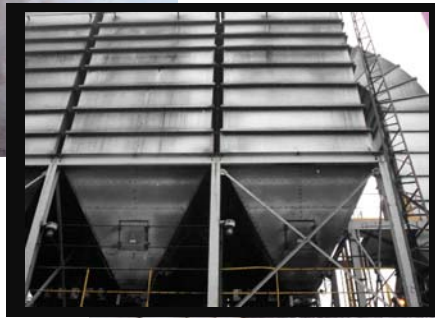
This Midwest Coke & Battery Plant was having problems with erosion and corrosion in their bag houses causing small holes that constantly needed welding.

USI recommended the entire structure be water blasted to get rid of any salts or excessive corrosion. The small holes were repaired with Metal-Tech RG; our 100% solid metal filled polymer repair system.

The entire structure was then coated with two 12 mil coats of 3M Scotchkote 152LV. 152LV is a 100% solid, surface tolerant, corrosion protection system. It was selected due to the inability to sandblast the surface and the lower operating temperature.
