Project: Butterfly Valve Refurbishment

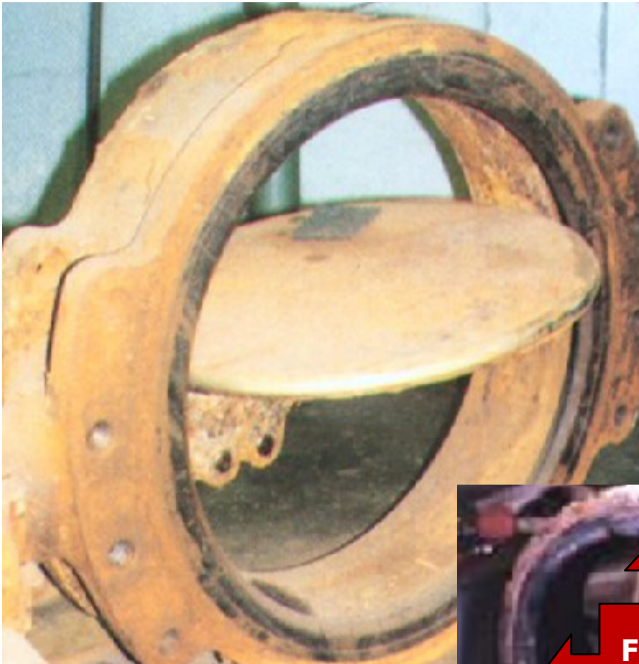
The butterfly valve at this chemical plant, that is responsible for controlling the fluid flow, was not working efficiently. The valve was in desperate need of refurbishment due to the abrasion and impact damage from years of service.
