Project: Concrete Stairway Repair

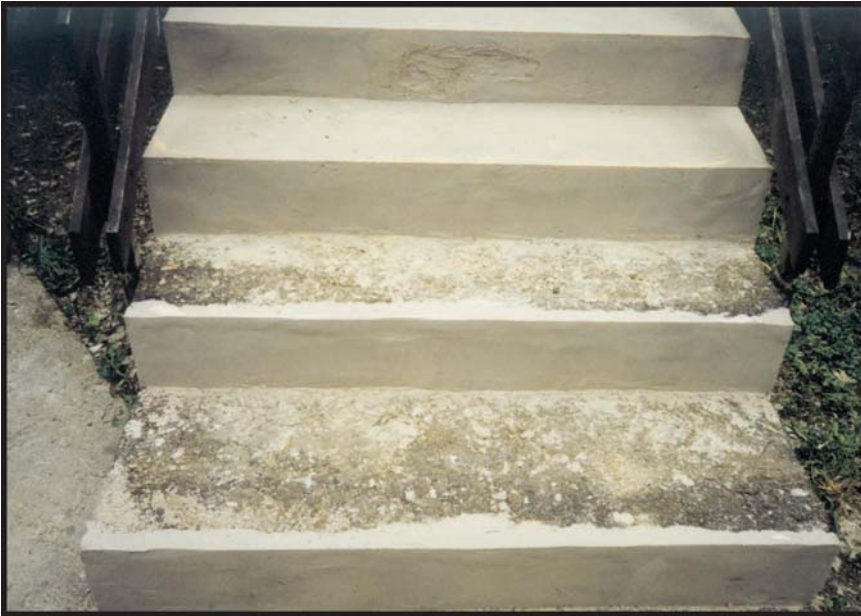
The project requirement was to completely repair and coat the stairway in this Recreation Area, which serves as one of the main access routes.

A heavy duty repair system was sought due to the "high wear" environment.

Thorough cleaning and roughening of the surface of the repair area was carried out before the application of a tack coat of Grano-Tech Primer. The damaged areas were then rebuilt using Grano-Tech which is our three component, solvent free, heavy duty epoxy repair mortar.

The entire surface of the concrete stairway was then coated with Floor-Tech FB.
