Project: Country Club Pool Area

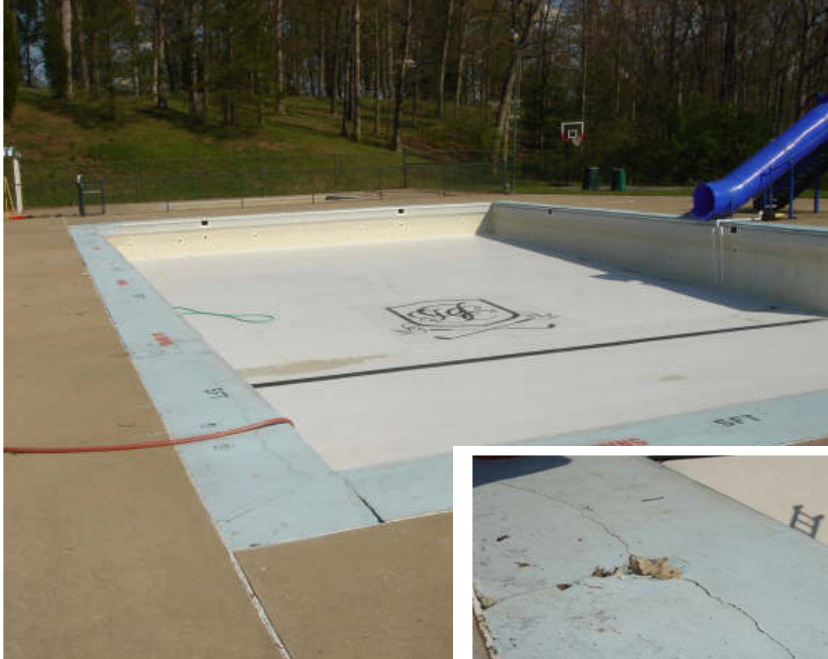
The concrete of the surrounding area of this pool was badly cracked and pitted.

The concrete was given a profile and repaired with Grano-Tech.

The entire area to be coated was primed with Uni-Tech GP and then coated with two coats of Floor-Tech WB. The Floor-Tech WB was tinted from light grey to the green you seen to the right.
