Project: Airport Taxi Way

The Problem

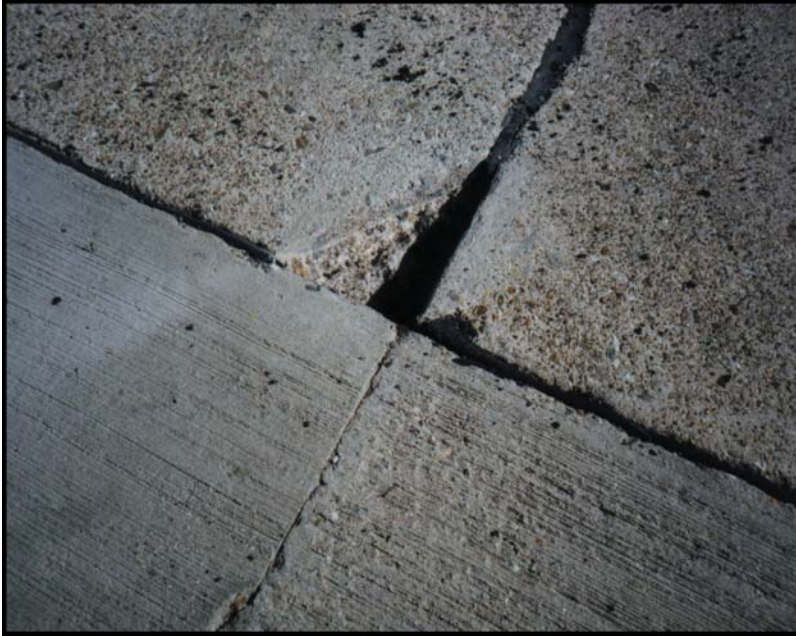
The airport was suffering from the continual breakdown and chipping of the edges of the concrete slabs on the taxiway where they are jointed. This was a continual problem due to the compressive forces of the aircraft nose wheels and the added problem of extreme weather cycle exposure. Extensive areas were in need of repair and being one of the busiest airports in the world, the timescale was limited.

Trials using Floor-Tech PR were carried out in the summer and monitored throughout the winter. The surfaces were prepared with scabblers to leave a good edge prior to the application of Floor-Tech PR. The areas for repair were only available for 7 hours throughout the night and all repairs had to be cured to a compressive strength of 20 N/mm. This was achieved by keeping the unmixed product warm prior to application and adding heat to the repaired areas to speed up the cure time. The repairs proved a complete success with the regular flow of aircraft using the taxiway the following morning.
