Project: Gas Holder

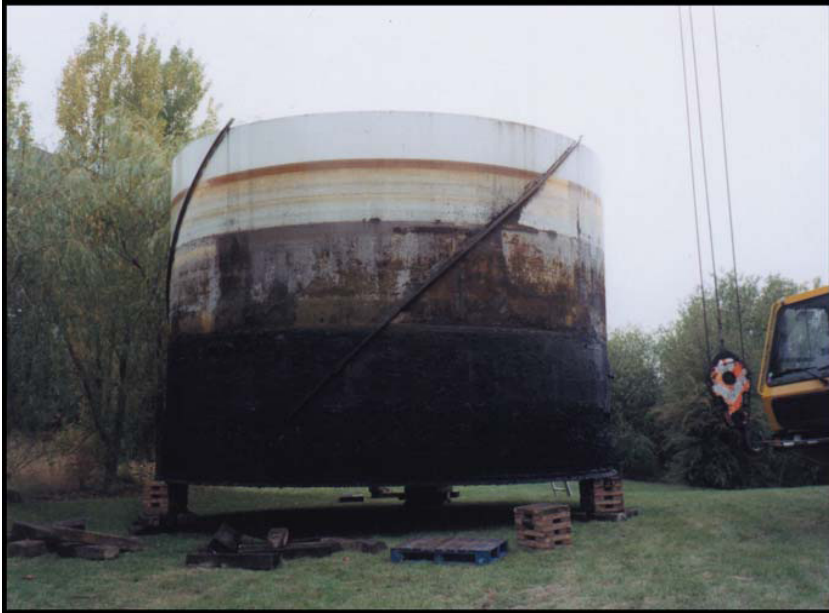
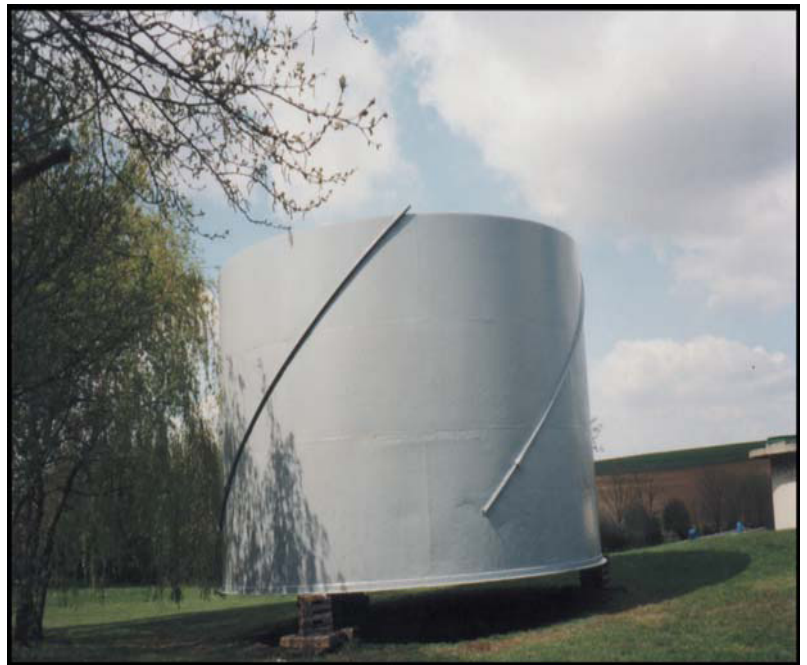
The gas holder had been allowed to deteriorate into a very bad condition. There was extensive rusting and after grit blasting, 50-60 holes had appeared in the lower third section. The gasometer was in need of a total upgrade.

After the entire gas holder had been grit blasted, the inside was coated with one coat of Uni-Tech MC Primer and two coats of the Chemi-Tech CR reinforced system. On the outside, the holes were filled with Wall-Tech LW, then the entire surface area was coated with one coat of Uni-Tech MC Primer and two coats of the Chemi-Tech.
