Project: Gate Valve Repair

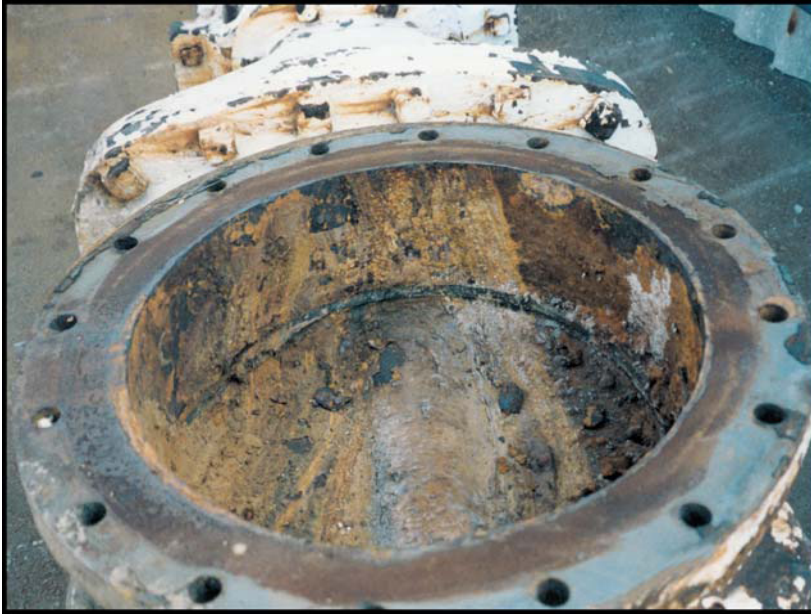
The surfaces of the gate valve shown in this photograph had been subjected to severe erosion and corrosion as a result of the very aggressive operating conditions.

Immediate repairs were required to extend the life of this expensive piece of equipment.

All loose material was scraped away. The surfaces were then blast cleaned to a minimum industry standard of Sa2½. Our multi-purpose ceramic epoxy Cerami-Tech EG was used to rebuild the internal surfaces of the gate valve, after which Cerami-Tech CR was applied.

Cerami-Tech CR is a solvent-free epoxy coating which provides a smooth, low friction finish as well as optimum levels of physical & mechanical strength and superior resistance to erosion and corrosion.
