## Project: High Pressure Tank Repair

### The Problem

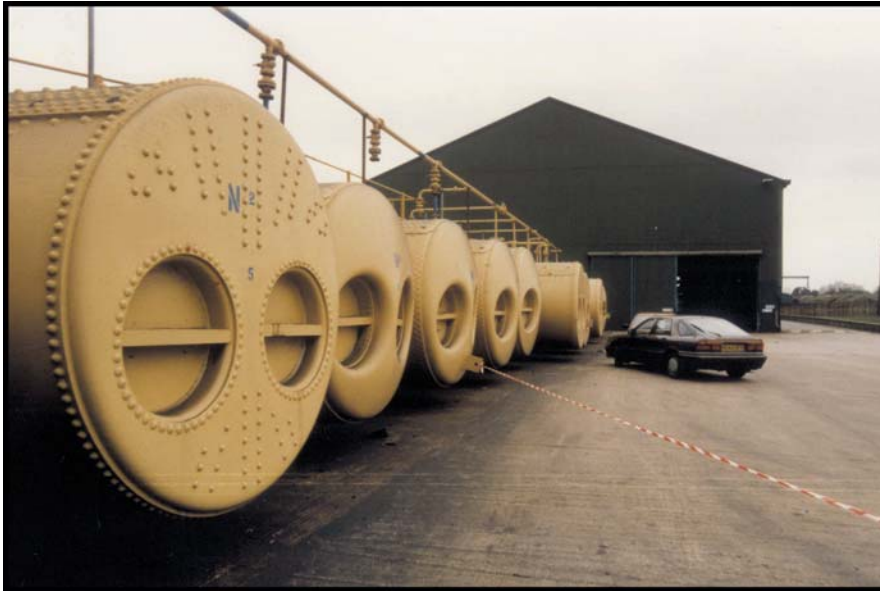
The large high pressure tanks shown in the photograph, measuring 3½m in diameter by 5m in length, were found to be leaking around the rivets.

The individual tanks were pressure tested to identify the areas to be repaired. The entire tank was then shot blasted and the problem areas diamond ground to create a key.

Repairs were then effected using our rapid curing, engineering grade polyurethane repair compound Metal-Tech RG. The tanks were then coated with Corro-Tech GP, which can be used as an excellent anti-corrosive primer/finish.
