Project: Metal Storage Tank Repair

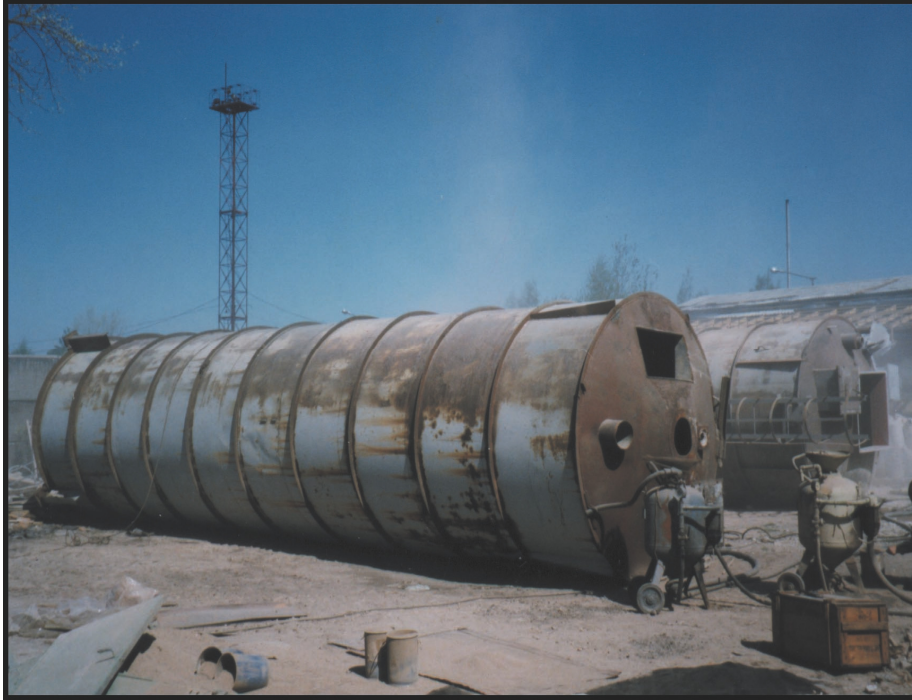
These bulk storage tanks have been severely damaged by corrosion. The corrosion was so bad the actual structural integrity of the tanks were threatened and immediate repair was required to prolong the service life of the tanks.

After careful consideration, the tanks were dismantled to remove the corrosion and repair the metal.

The metal tanks were blasted to remove surface contaminants. Uni-Tech MC Primer was applied to the tank; this solvent based primer provides excellent adhesion to metal substrates. Followed by two coats of Uni-Tech UV, that was applied to provide long term protection.

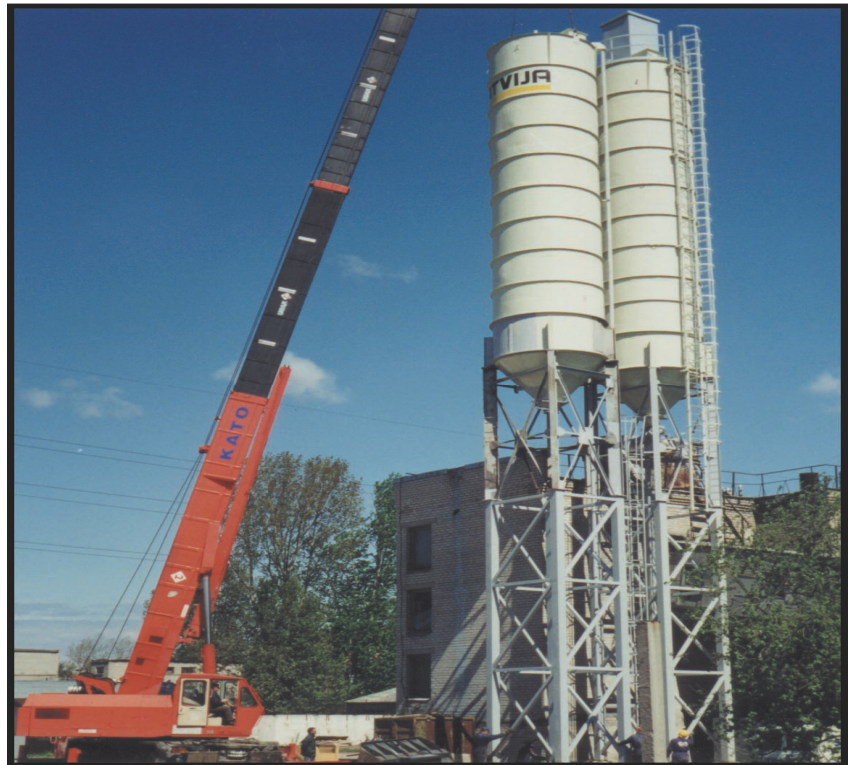
The company was delighted by the application because the corrosion problem has been solved and the tanks were as good as new in appearance and more importantly, performance.
