Project: Parking Garage

The Problem

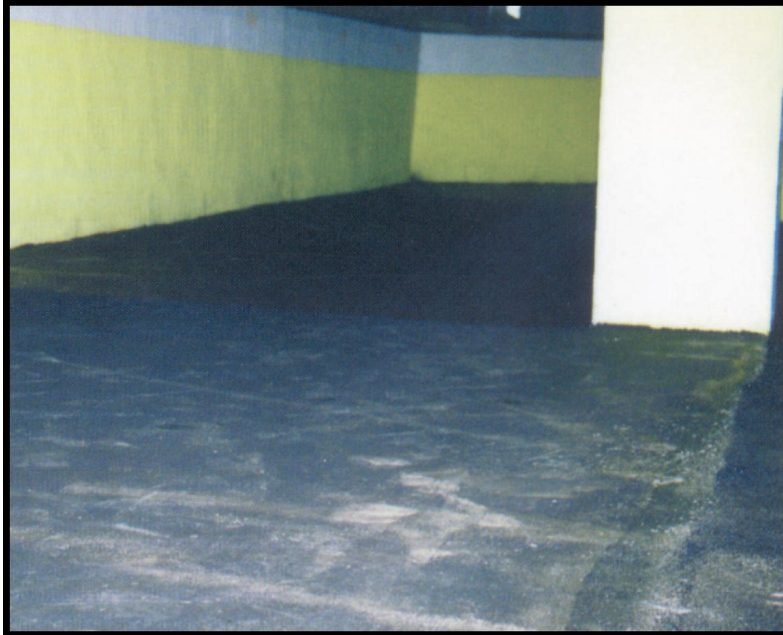
The asphalt floor of this car park had become badly damaged due to the high level of use. In addition, the existing coating had cracked badly due to its rigidity.

The surface was first prepared by cleaning and scabbling. An asphalt system was then applied to ensure an even floor surface.

Floor-Tech FB Primer was then applied to the asphalt to ensure good adhesion. This was then over coated with Floor-Tech FB which has provided the required impact and abrasion resistance with the flexibility not to crack due to the slight movement of the asphalt.
