## Project: Processing Pump Refurbishment

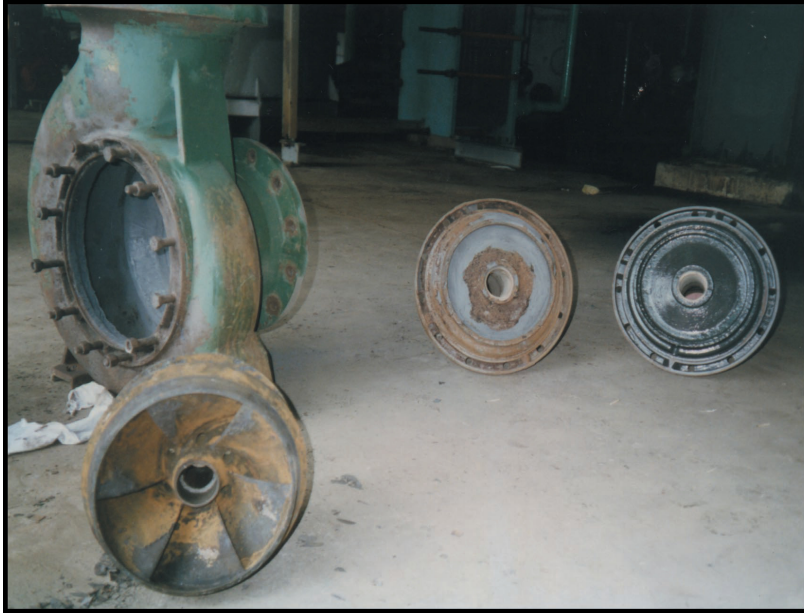
The pumps used by this processing company were in poor condition. The efficiency of their operation was now being affected and the pumps therefore required rebuilding or replacing.

The pumps were first blast cleaned and the corroded areas inside the pumps were rebuilt with Cerami-Tech EG.

Once this had cured, the internal surfaces of the pumps were lined with two coats of Cerami-Tech CR, a low friction corrosion resistant lining.

In most cases, the external surfaces of the pumps were coated with two coats of Corro-Tech GP.
