Project: Steel Roller Stand Repair

The Problem

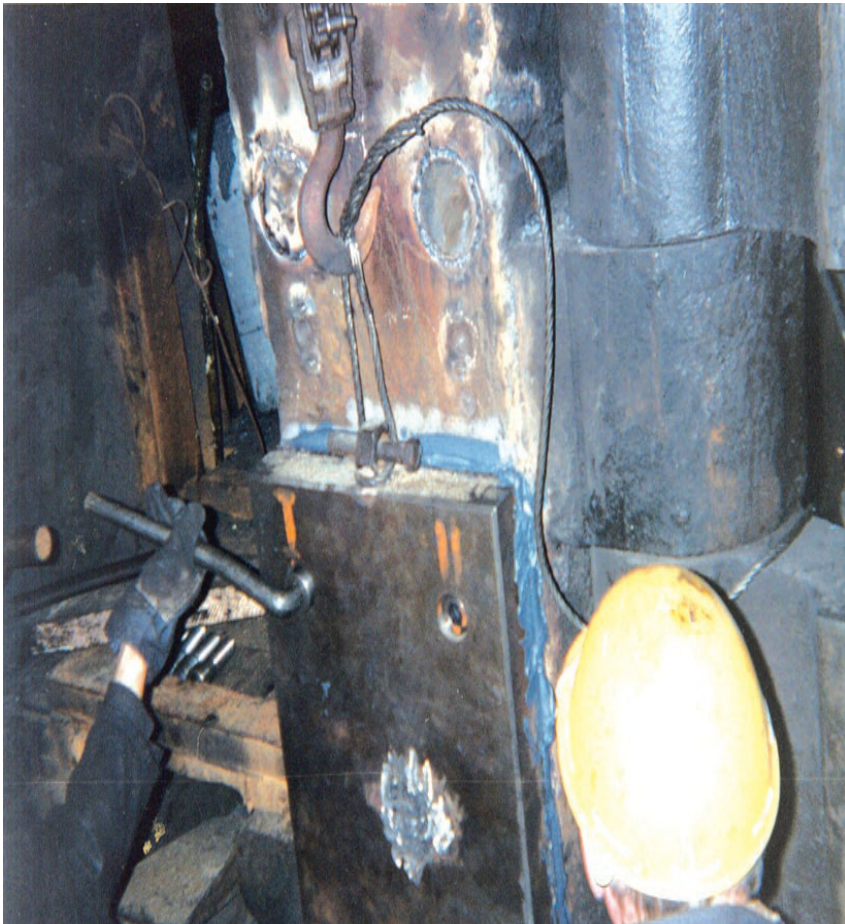
The gap between the sliding plates (1.8ft x 6ft) and the frame of the stand had increased to 20mm due to the heavy impact caused by the speed and heavy weight of the steel ingots being rolled. The gap was affecting the accuracy of thickness of the steel sheet.

The roller stand was suitably prepared, which included blast cleaning the frame of the stand and the reverse side of the sliding plates. Guides for the plates were made using theodolites, after which each of the eight sliding plates were bonded/secured to the frame using Metal-Tech XG in a continuous 24 hour operation.

This refurbishment project was completed over 7 years ago using 661 lbs of Metal-Tech XG. The client has since reported no further problems.
