Project: Tank Chime Repair

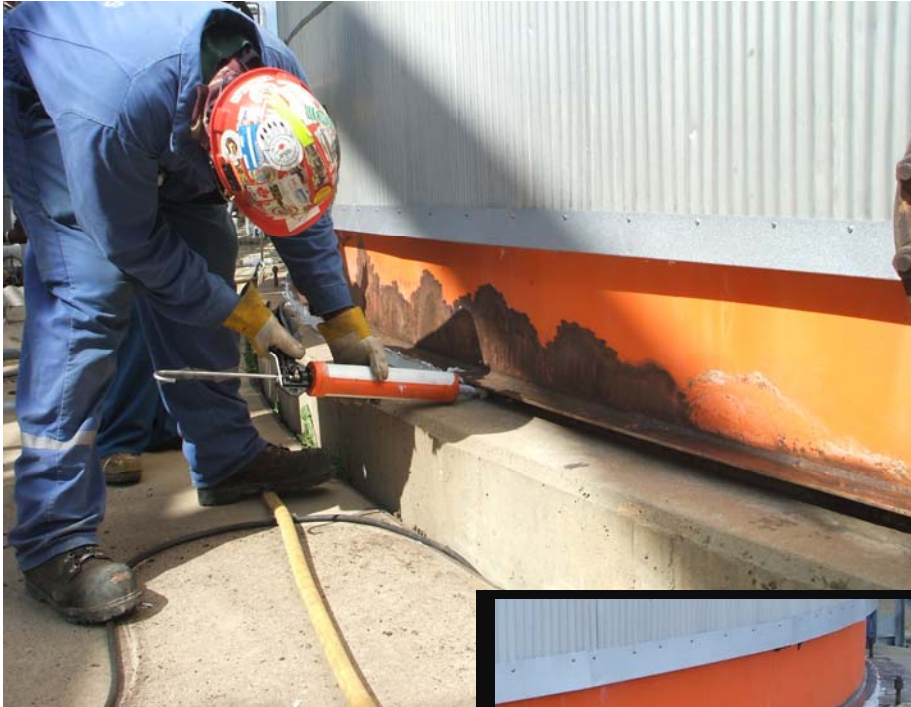
An oil company was looking for a cost-effective and long lasting repair solution for their tank chimes. As seen in the picture, there was about an inch and a half gap that needed to be repaired and sealed.
