Project: External Pipe Protection

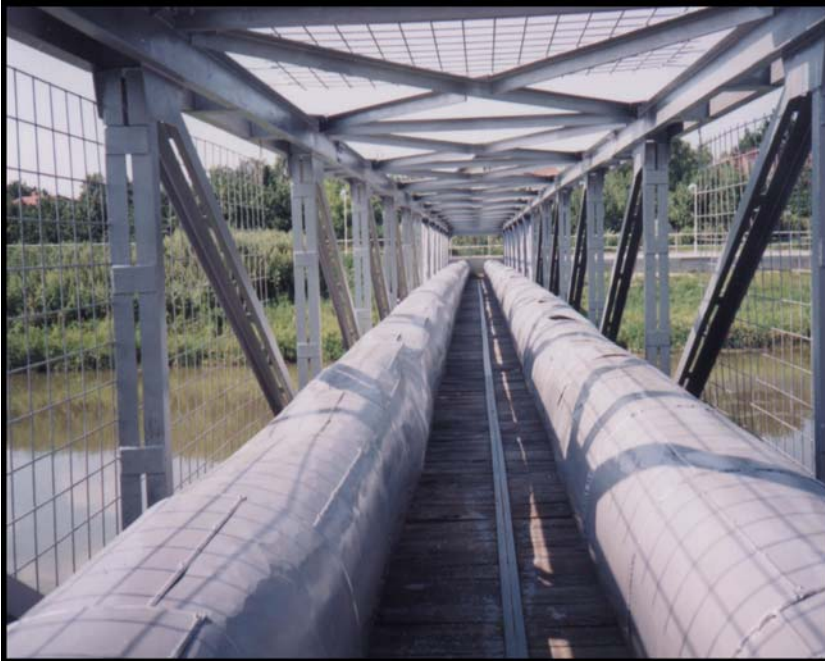
This pipeline crossing a river had badly corroded and was in need of urgent protection.

The pipe had been in place for many years and corrosion had occurred with regard to the supporting steelwork and the actual pipeline.

The entire structure was water blasted using high pressure water cleaning to clean both the structural steelwork and the pipeline in question.

After water blasting, all steelwork and areas of pipeline were protected with one coat of Corro- Tech GP with the material being applied by brush.

Brush application ensures complete penetration and protection of the structure. This application has been a complete success for the Water Authority.
