## Project: Intake Pump Housing Refurbishment

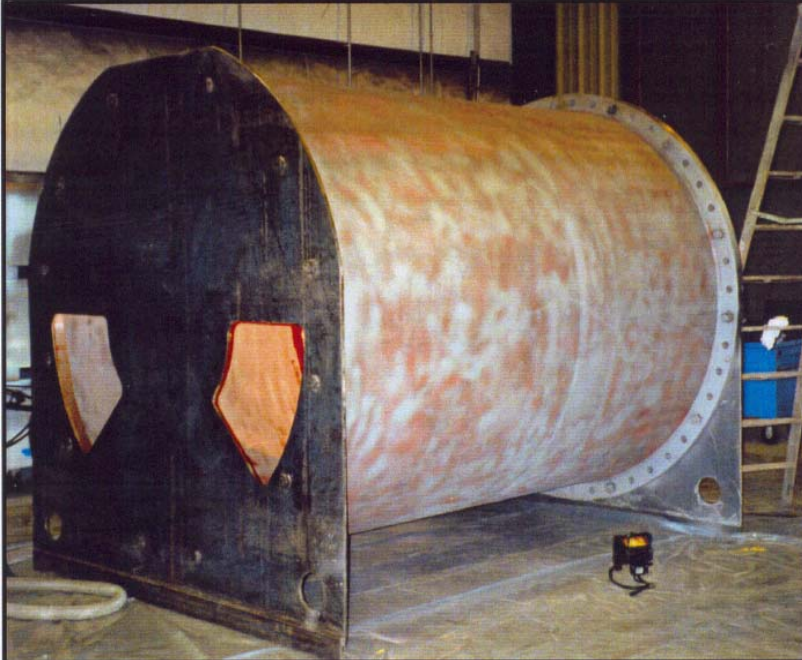
The Intake Pump at this fossil fuel plant had become badly cavitated due to years of service in a salt water environment. The client sought a solution which would protect the pump both inside and out but not affect its efficiency.

The surfaces to be coated were abrasive blasted with angular grit and then left to allow all of the salt contaminants to bleed out of the metal. The surfaces were then re-blasted to remove any residual salt contamination and create a profile.

The interior of the pump was coated with our resurfacing and lining system, Cerami-Tech CR, as it offers superior resistance to salt water and provides a low friction surface. As the pump is normally submersed in salt water, its exterior was coated with Chemi-Tech EP to protect the pump against chemical attack from aqueous chemicals.
