Project: Natural Gas Line Repair (Offshore platform)

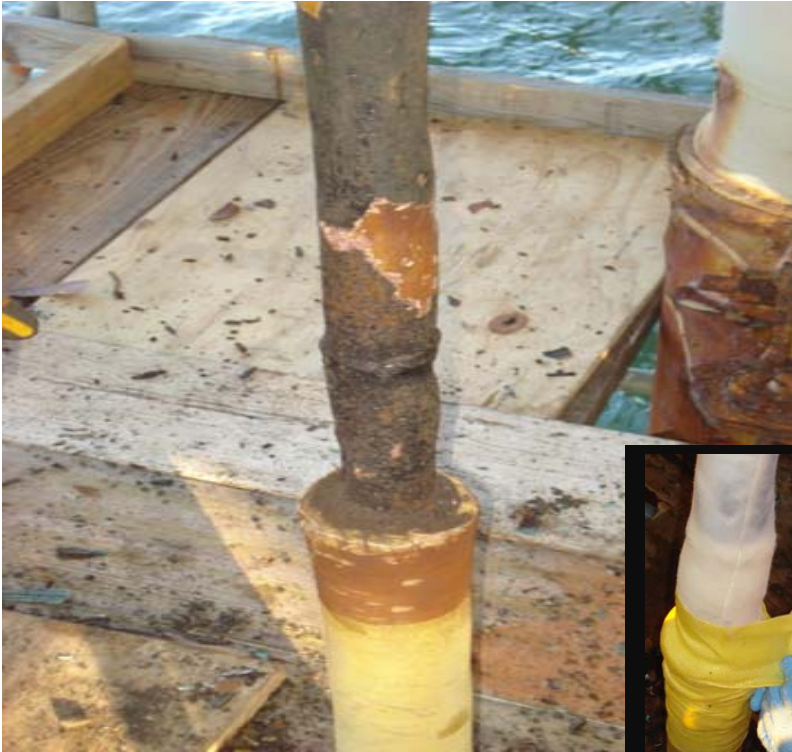
This 2" offshore natural gas line had major wall loss and several pinhole leaks due to corrosion.
