Project: Primary Sludge Pump Repair

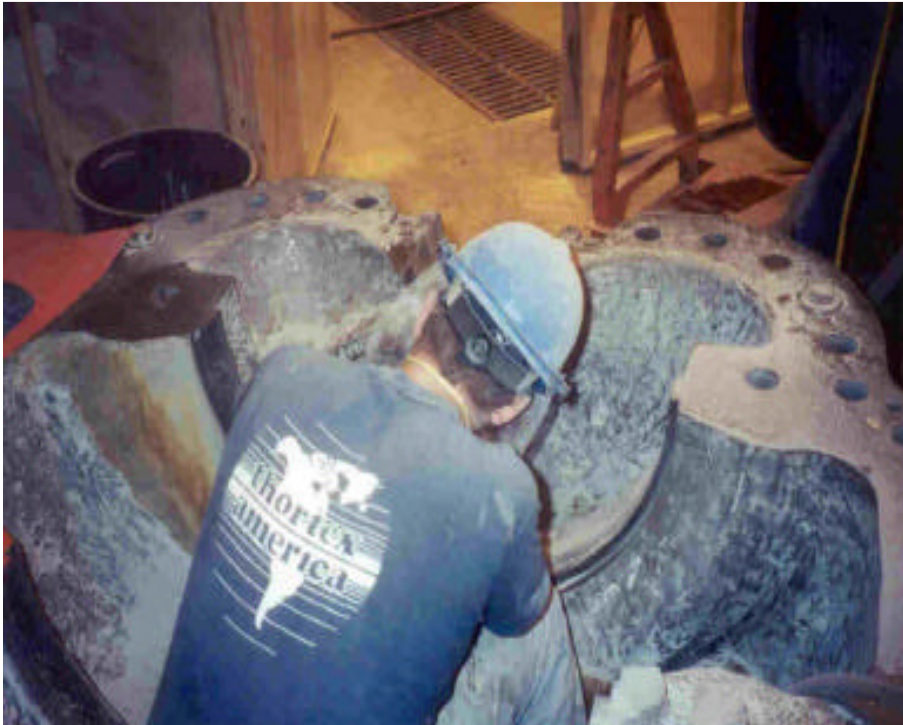
This waste water treatment plant's primary sludge pump wasn't working to full capacity because of years of wear and erosion.

Abrasive blasting was used on the pump housing and then the pump was rebuilt to its original tolerances using Cerami-Tech EG and finished with two coats of Cerami-Tech FG.
