Project: Secondary Containment Repair

The Problem

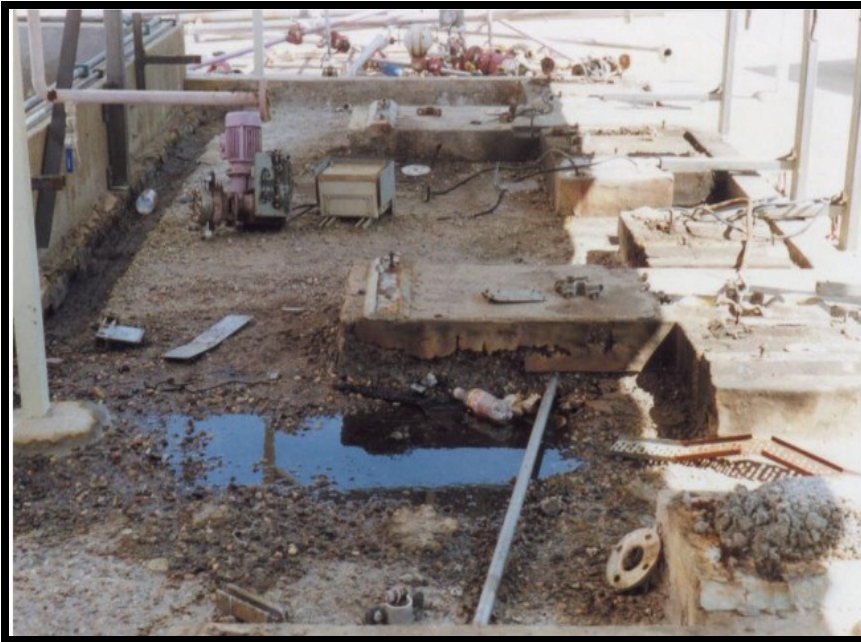
A power station floor and secondary containment area was severely eroded from pumps and tanks spilling sulfuric acid on the base and runoff areas.

The damaged concrete was broken up and removed. The damaged areas were rebuilt with new concrete. Then the area was primed with Uni-Tech MC Primer to ensure proper adhesion.

They applied two coats Chemi-Tech UC to the entire area. A two component, solvent free coating; Chemi-Tech UC provides an excellent for both steel and concrete surfaces subjected to aggressive acids, solvents and industrial chemicals. Where slip resistant surfaces were required an aggregate was scattered into the second coat.
