## Project: Sulfuric Acid Containment Area

### The Problem

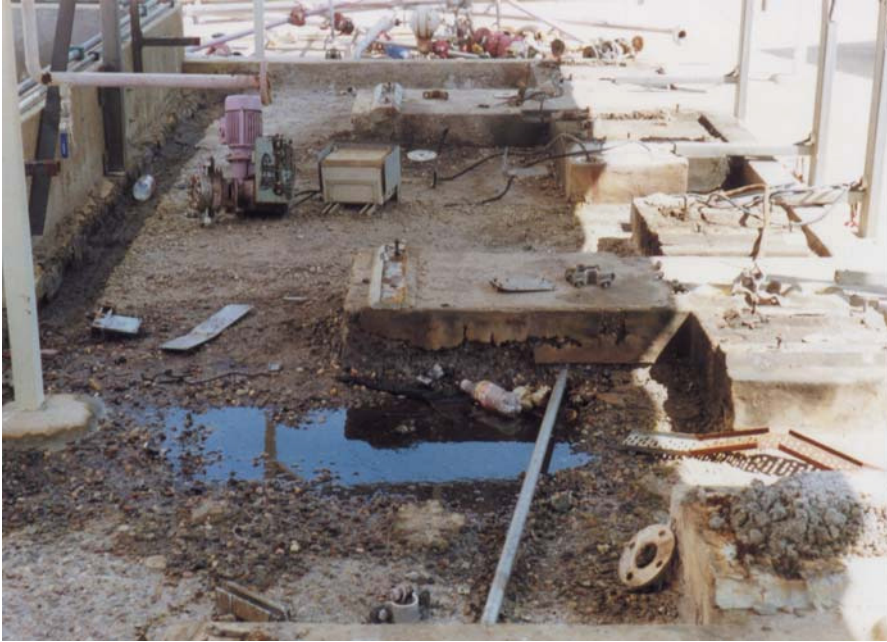
At this power station, there were many sulfuric acid spillages from the pumps and tanks operated by the power company. The sulfuric acid had severely eroded the concrete plinths and the secondary containment areas.

The old concrete was broken up and removed; the secondary containment areas and plinths were rebuilt. The area was primed with Uni-Tech MC primer, followed by two coats of Chemi-Tech UC.

Where a slip resistant surface was required, and aggregate was scatter into the second coat of Chemi-Tech UC and then a third coat of UC was applied over these areas to seal the grip and provide a chemical resistant surface.
