Project: Roof Refurbishment

The Problem

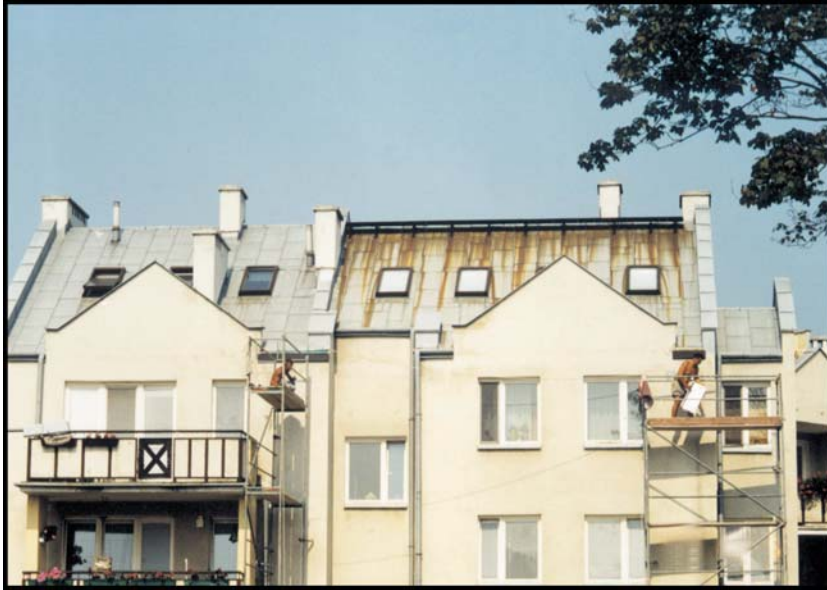
The suburban block of apartments, shown in the photograph, was built in the late Nineties, the roof of which was covered with zinc metal sheets. Due to the low quality of the roofing material, the roof had started to show signs of corrosion and leaks had begun to occur, especially at the joints of the metal sheets as well as against the parapets, upstands and chimneys.

All surfaces were cleaned to remove any dirt & contamination and the deeply corroded sections of the substrate patch primed with Corro-Tech GP. The entire roof was then primed with Uni-Tech MC Primer followed by one coat of Poly-Tech, into which Poly-Tech Reinforcing was embedded. A second coat of Poly-Tech was then applied.
